Chandler Heights Fissure Swallows Horse

By Mimi Diaz, Arizona Geological Survey

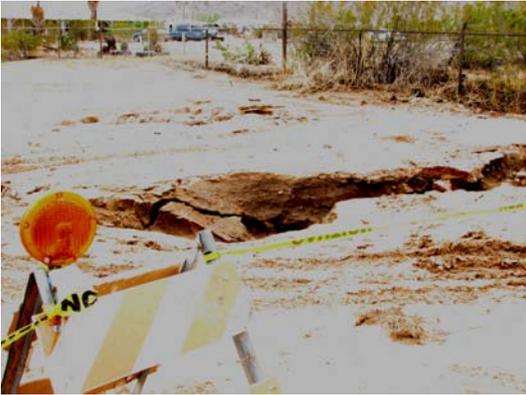
An earth fissure in Chandler Heights re-opened Saturday night (July 21, 2007) during a thunderstorm that dropped two inches of rain in an hour, and effectively swallowed a horse, in addition to damaging corral fences and San Tan Boulevard, and shutting down Happy Road at 195th Street (Figure 1).

Figure 1. Fissure that re-opened across Happy Rd at 195th St in Chandler Heights during a storm on Saturday, July 21, 2007. (Photo by M. Diaz, AZGS.)

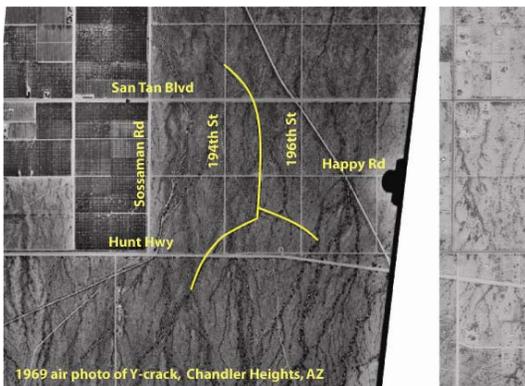
This fissure, known as the “Y-crack” for its shape, extends from just north of the San Tan Mountains and crosses the Hunt Highway and San Tan Boulevard before curving westward and stopping short of Sossaman Road (Figure 2), and is visible on aerial photographs as far back as 1969. As the Chandler Heights area developed, the fissure was backfilled in places.

Figure 2. The north-south trending portion of the Y-crack runs immediately west of where 195th Street would be in this aerial photograph from 1969. (Photo courtesy Flood Control District of Maricopa County.)

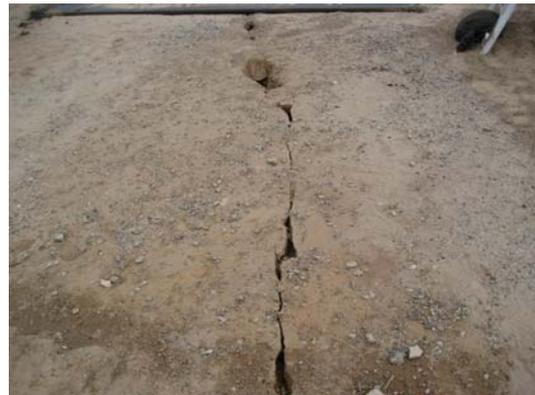
During Saturday’s rain event, water flowing through the Y-crack undermined the backfill, creating a large void, and surface runoff caused the crack to widen. When the backfill finally collapsed, it left a gaping hole that was more than forty feet deep in places, and fifteen feet wide in others. Yellow tape and barricades extend across the intersection of 195th Street and Happy Road, and warning barricades are on either side of San Tan, east of Sossamon, with four metal plates spanning the fissure where it crosses the road (Figure 3).

Figure 3. Surface crack exhibited where San Tan Blvd crosses the Y-crack, west of 195th St. Barely visible in the top part of the photograph is one of the metal plates straddling the fissure since the storm. (Photo by B. MacFarlane, AZGS.)

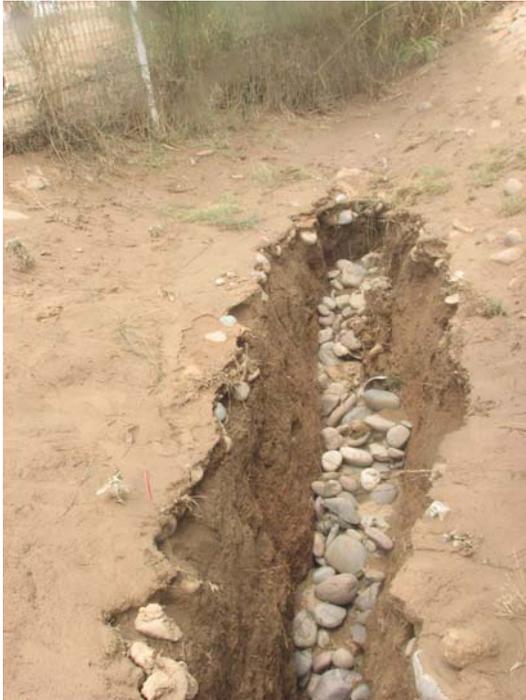
People frequently backfill fissures as a mitigation effort; however, backfilling is ineffective. Fissures form at the groundwater table and work their way upward. Water flows through the fissures

in the subsurface, undermining the fill, and allowing for catastrophic collapse (Figure 4). This process is enhanced by runoff from precipitation, which serves to widen the surface expression of the fissure.

Figure 4. Portion of the y-crack north of San Tan Blvd that had been filled and lined with river rock. The fill was undermined and the rock collapsed into the fissure after Saturday's event. (Photo by M. Diaz, AZGS.)

The most effective fissure mitigation strategy is to avoid the fissures altogether—keep buildings and infrastructure well away from them, and use caution when traversing those areas. Keeping excess runoff and drainage away from the fissure will also help minimize widening. And, avoid putting things in fissures that you would rather not drink (Figure 6).

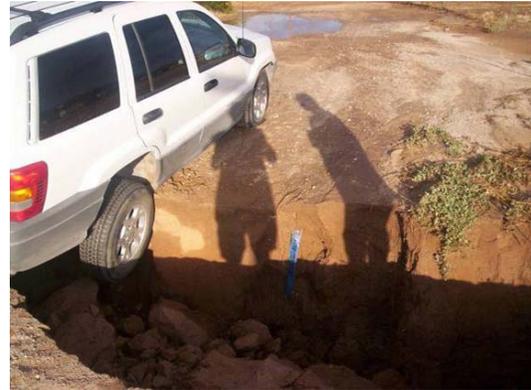
In addition to trenches that open unexpectedly (posing hazards to motorists and whatever happens to be on top of the fissure), other hazards associated with fissures include changes in drainage patterns that cause areas to flood that previously didn't, breaking water, sewage, and other lines that cross the fissures, and groundwater contamination (Figure 5).

Figure 5. Vehicle that unexpectedly encountered the newly re-opened Y-crack at Happy Rd and 195th St after the August 2005 event. (Photo by K. Fiebelkorn.)

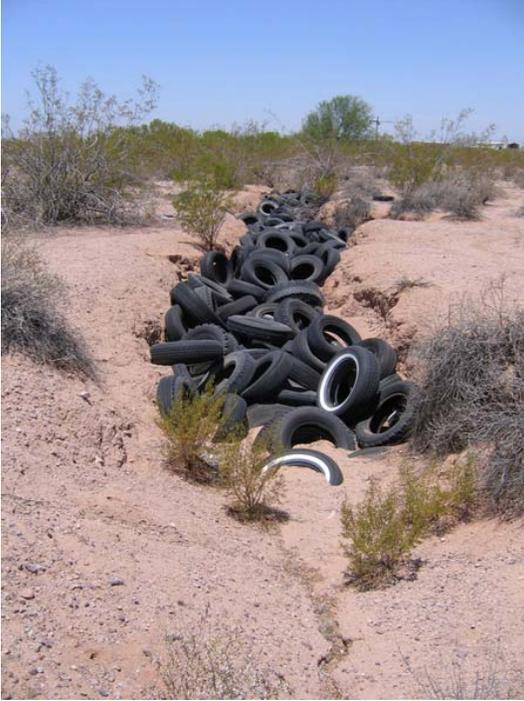
Unfortunately, many people view these linear cracks in the ground as the ideal dumping spot for unwanted materials, like pharmaceuticals, refrigerators, tires (Figure 6), manure, garbage, etc.; however, nothing could be further from the truth. Fissures provide a direct conduit for the contaminants to flow into the groundwater, so anything dumped into

a fissure will pollute the water directly instead of being filtered through many layers of sediment.

Figure 6. Fissures open directly to the groundwater table; objects placed in fissures can directly contaminate the groundwater. This fissure is southwest of Baseline and Ironwood in the East Mesa/Apache Junction area. (Photo by T. Shipman, AZGS.)

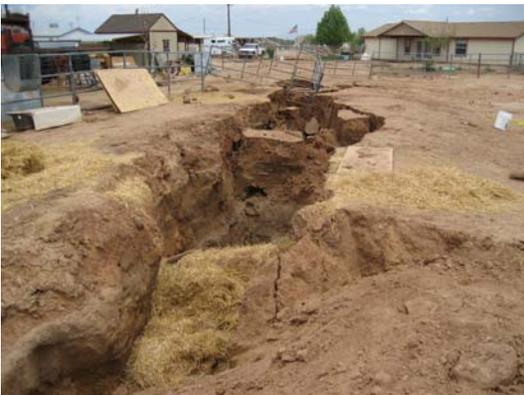
Sadly, the re-opening of the Y-crack ended in tragedy when a 13-year old, 1100 pound horse, Cash, fell into the fissure as the backfill collapsed underneath him (Figure 7). Despite the 15 hours of valiant rescue attempts by his owners and rescue crews, Cash died before they were able to extract him from the fissure.

Figure 7. Portion of the Y-crack that collapsed underneath a horse during Saturday's thunderstorm. The fissure here is roughly 10 feet wide and 12-15 feet deep. (Photo by B. MacFarlane, AZGS.)
