GEOLOGIC CONDITIONS AND HIGHWAYS

Some of the effects of geology
on
highway planning and construction.
by
Richard T. Moore*

Volume 3, No. 3 Sept. 1973

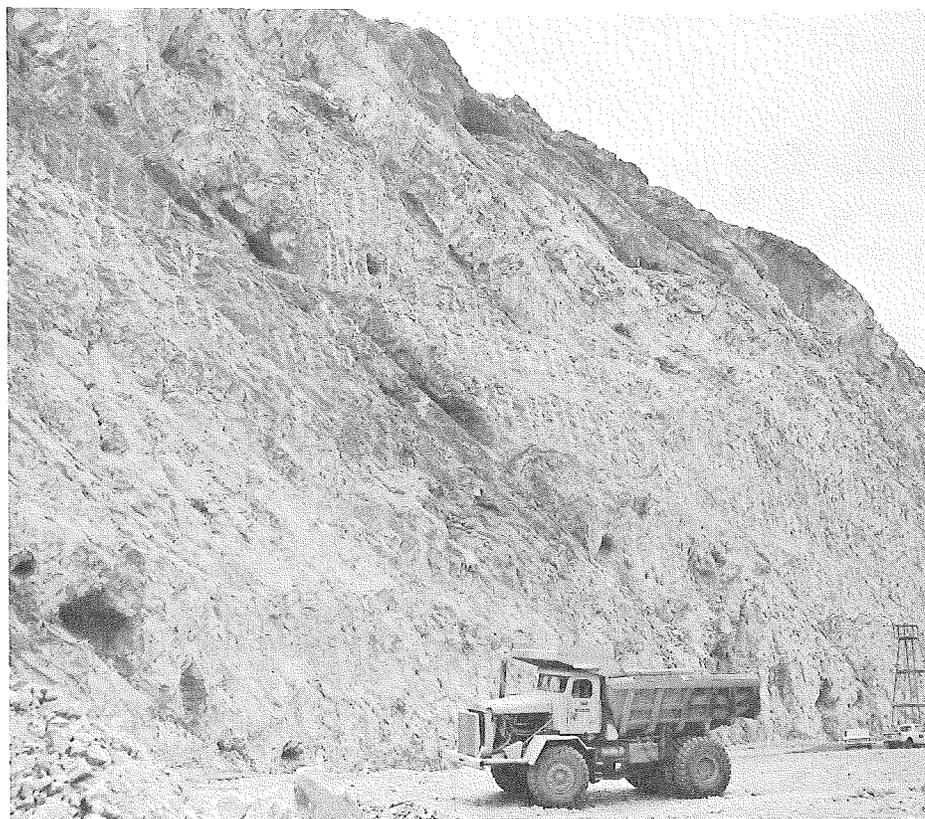
Fig. 3. Excavation of road cut near west end of Virgin River Gorge. More than 1.2 million cubic yards of rock was removed in a 2,000-foot section of roadway by presplit blasting.

(figures 3, 4, 7, 8, and 9). Notwithstanding this technique, however, considerable benching, and in places, flattening of slope was required; and, as between Stations 675 and 695, a distance of 2,000 feet, about 300,000 cubic yards of overbreak occurred. Side hill cuts on the order of 300 feet in height are not uncommon in the Lower Gorge, and some of these required as many as 5 benches, each approximately 50 feet high, as catchments for falling rock.

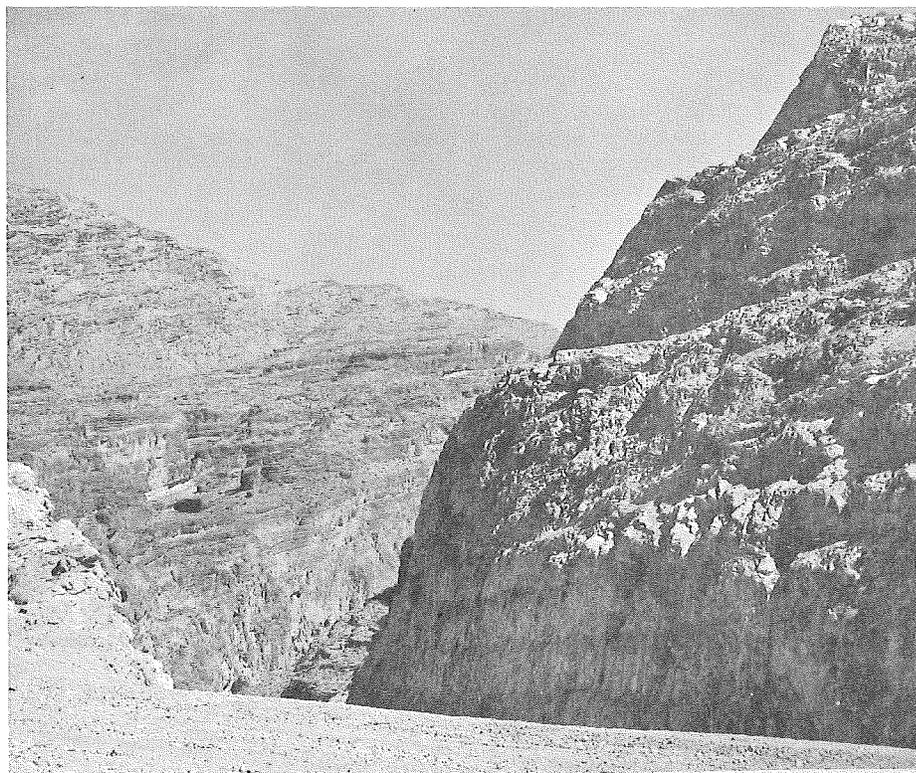
Fig. 4. View east (upstream) from near station 691. The cut to the right is 340 feet high.

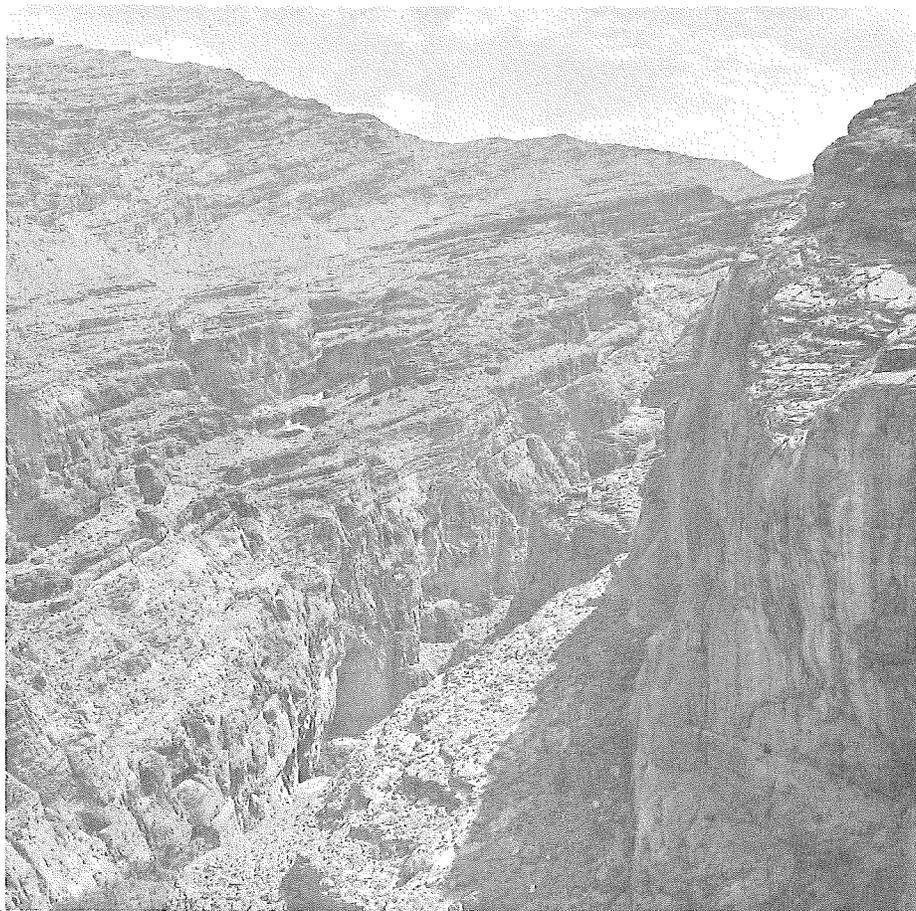
Fig. 5. Preconstruction view of Virgin River Gorge near site of Bridge One.

from the west flank of the Virgin Mountains to the vicinity of Sullivan's Canyon (figures 2A, B, and C). It is by far the most complicated segment in the geologic sense and the most rugged from the viewpoint of topography. (See figures 1, 5, and 8.) Rocks exposed in this segment of the alignment consist of extensively faulted, fractured, and tilted Paleozoic limestones. These are, in ascending order, undifferentiated limestones of Ordovician and Devonian age, the Redwall Limestone of Mississippian age, and the Callville Limestone of Pennsylvanian and Permian age.

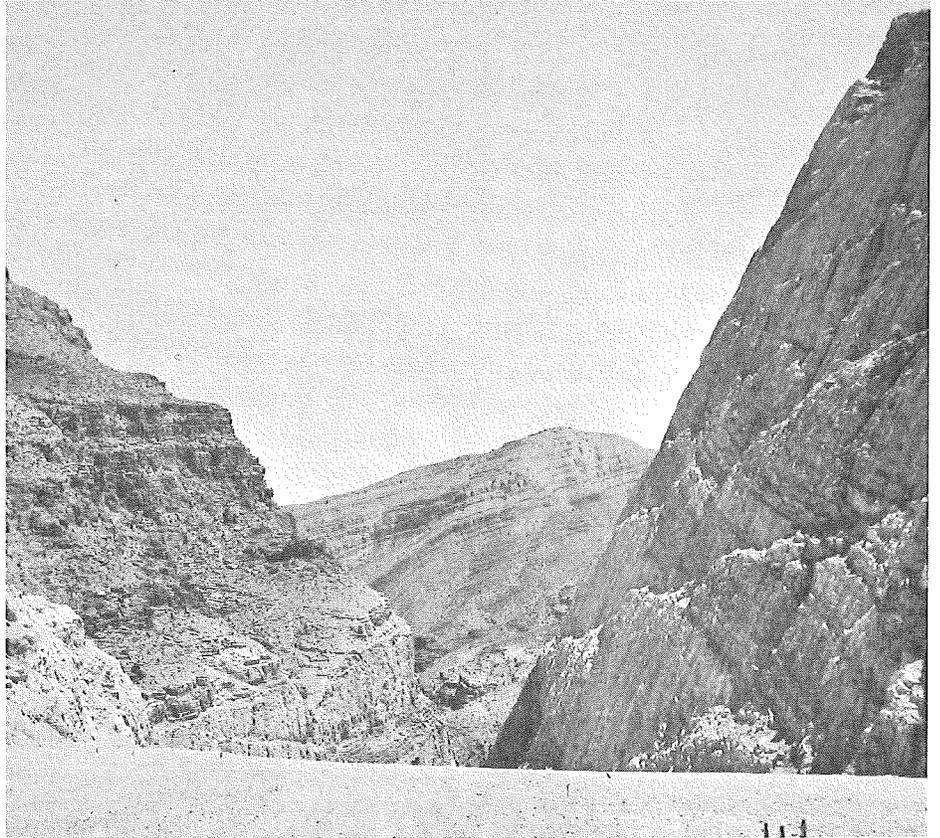
Fig. 9. Details of cut in vicinity of station 737. This side-hill cut is approximately 300 feet high. The attitude and fractured nature of the limestone necessitated the cutting of five benches as catchments for falling rock.

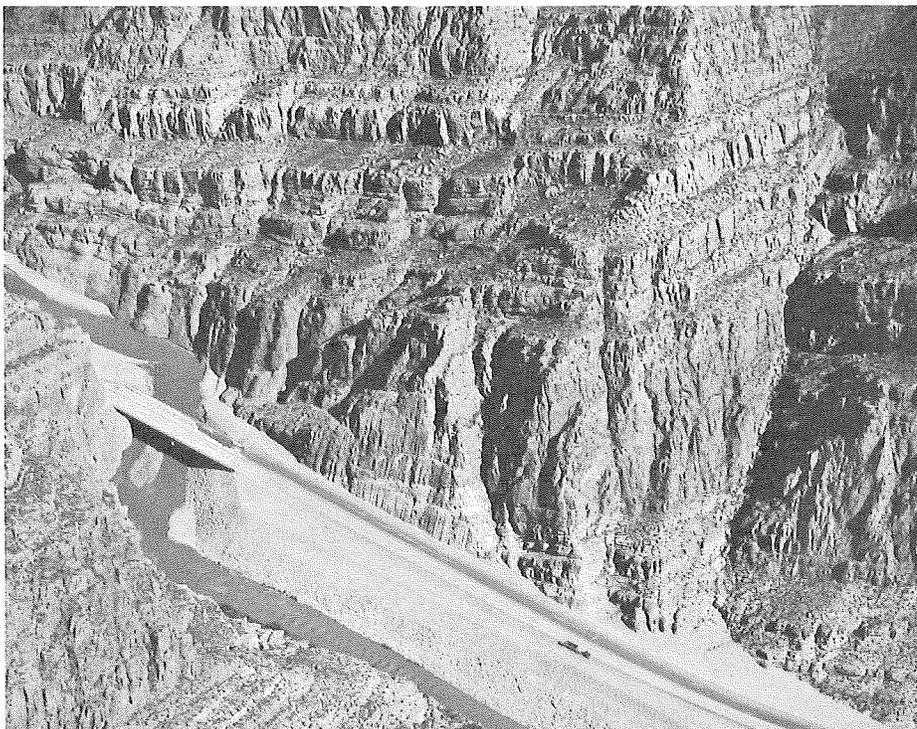
Fig. 10. Aerial view of Bidge Two and channel relocation south of roadfill. An impression of the scale of the river gorge and the construction project can be obtained from the relative size of the tractor trailer rig on the roadway (view looking north).

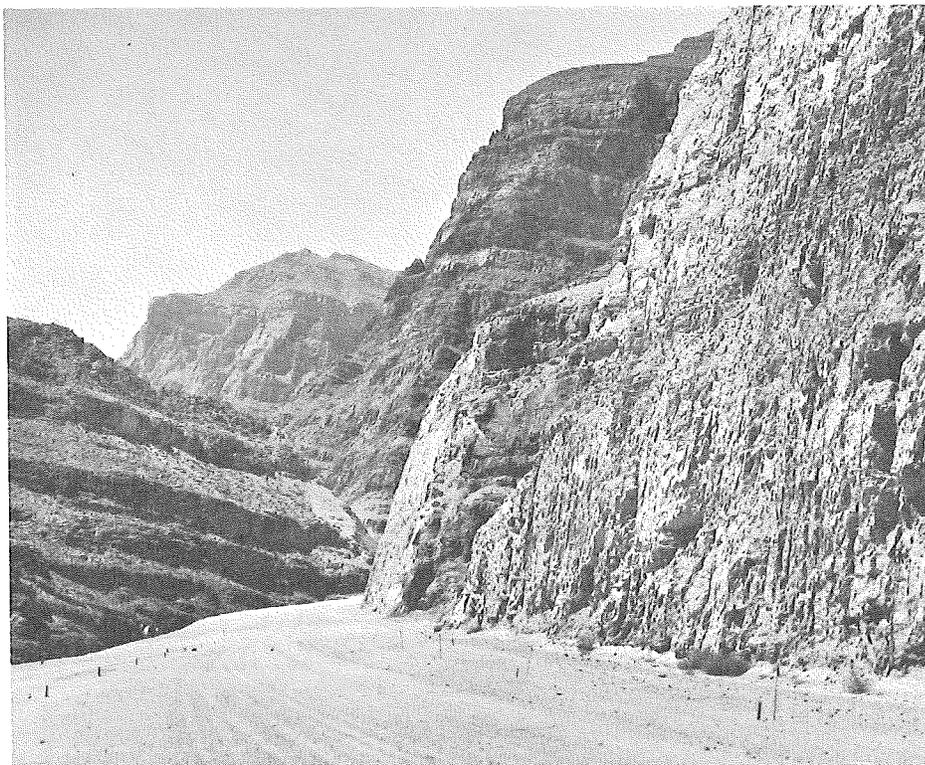
Fig. 12. View looking west at side-hill cut near station 845. Although the rock is moderately fractured, presplit blasting produce a smooth and even face.

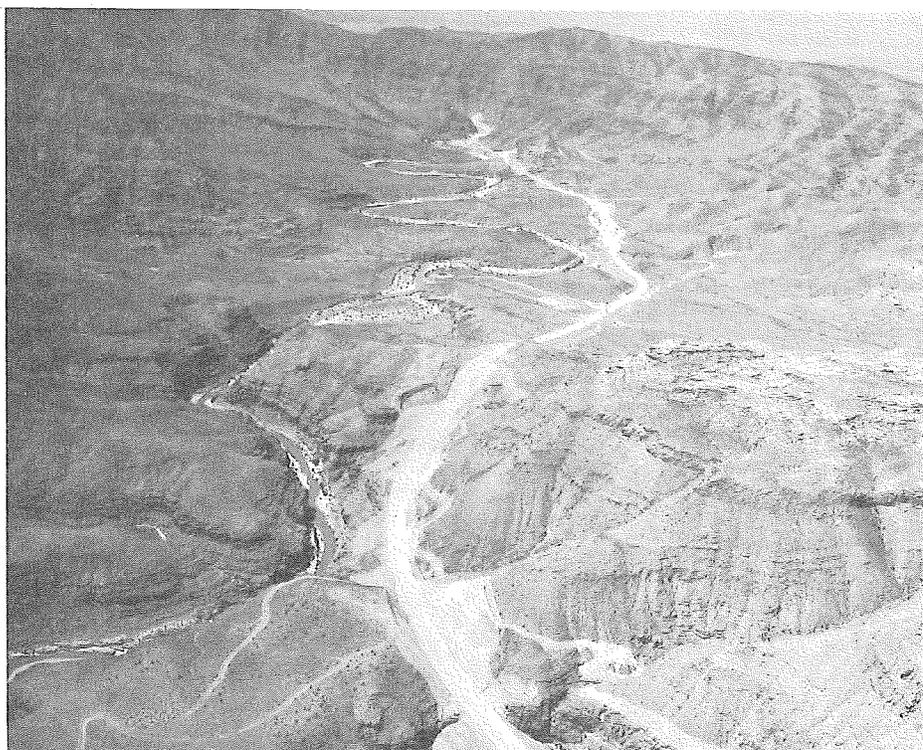
Fig. 13. View west toward Cedar Pocket — Grand Wash fault segment of I-15.

The third segment of the alignment, that following the Middle Gorge of the Virgin River, extending from Sullivan's Canyon, east to the mouth of Black Rock Canyon (figures 2A, 13, and 14), is marked by only relatively mild deformation and the surficial rocks are almost exclusively sandstones of the Supai Formation locally overlain by thin gravels, remnants of once more extensive terrace deposits.

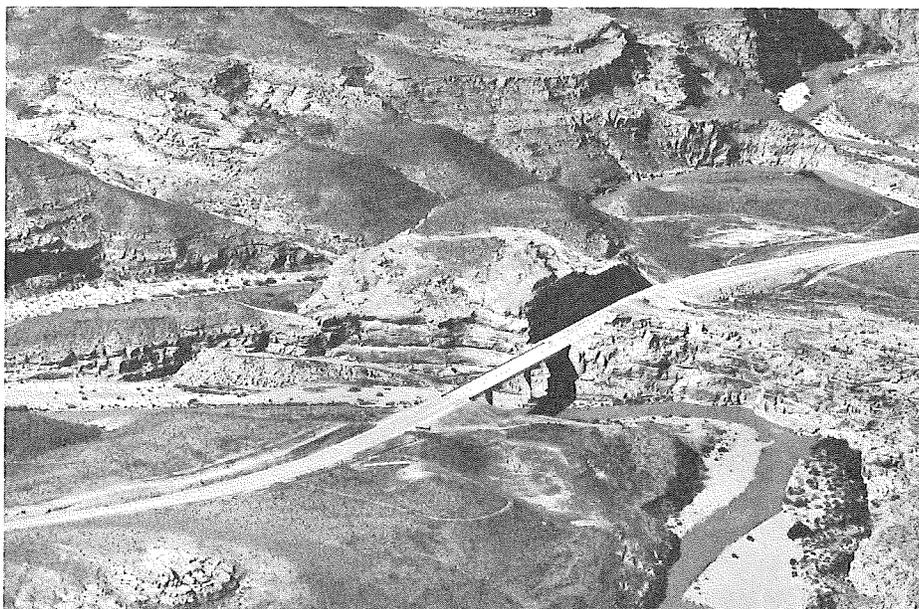
Fig. 14. Aerial view of Bridge Five across Virgin River. The original proposal called for an arch structure but foundation conditions were later found to be unsuitable and a three-span pier-supported structure was built.

At the eastern end of this segment, the alignment crosses the Virgin River before entering into Black Rock Canyon. As originally recommended, the structure proposed for this location was an arch bridge, presumably with the skewbacks founded on firm Supai Sandstone in either embankment. Site examination prior to final design, however, indicated that bedrock at the eastern abutment was more than 50 feet beneath sand fill as the result of an old scour hole cut by the

Virgin River. This necessitated that the design be changed and that a pier-supported bridge be substituted for the arch structure.
