Slope Form and Stability

in the Northwest portion of the Mount Lemmon Quadrangle, Pima County

by Bruce J. Murphy
Assistant Field Geologist

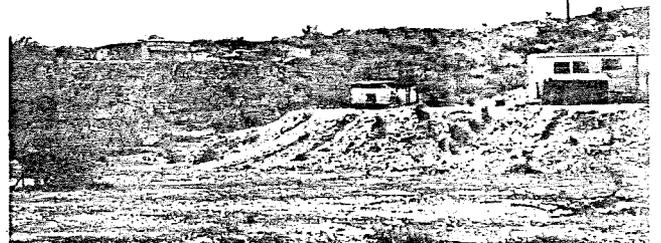
Photo 5. Series of retaining walls to stabilize fill slope. Home being constructed on fine-grained recent alluvium overlying Ft. Lowell Formation in map unit 4.

Photo 6. Improper maintenance of fill sites. Erosion of the slope may cause future instability, while lowering the aesthetic value of the property.

Fills. The improper design of fills on which foundations are placed can result in severe settlement of the structure (see photographs 5 and 6). This can be caused by

- (1) Situating the fill on existing vegetation or compressible soil;
- (2) Inadequate drainage of the fill, causing seepage and saturation of the building site;
- (3) Improper compaction of the fill.

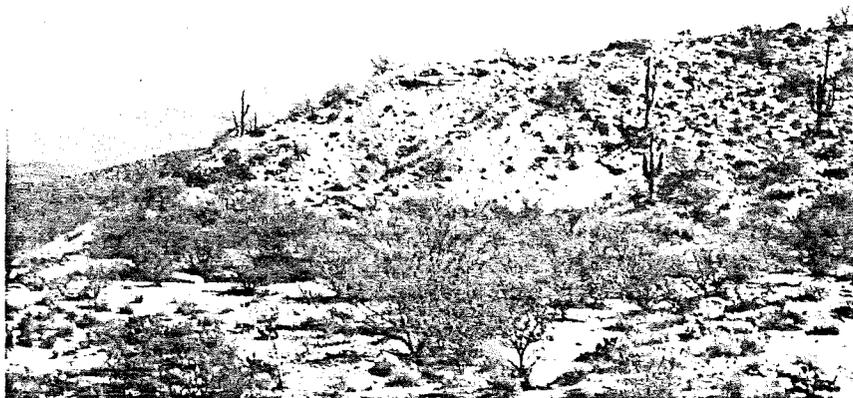
Photo 7. Landslide in surficial alluvium. Failure of material similar to model in figure 2a.

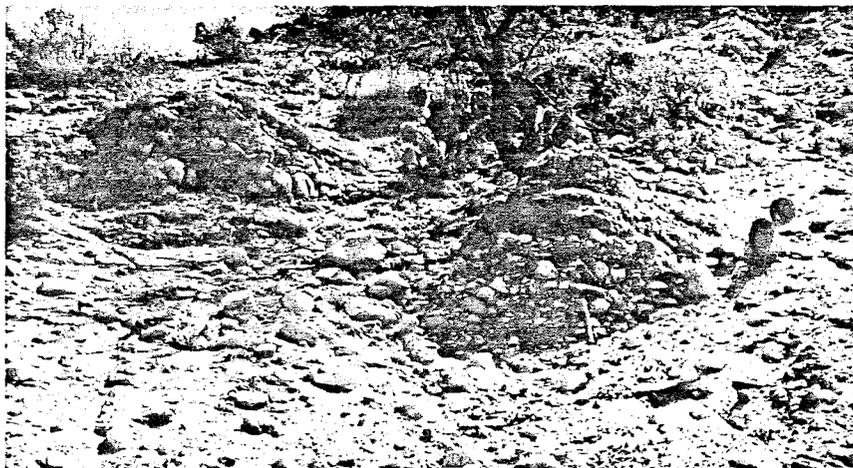
Photo 8. Close-up of photo 7. Looking into failure plane. More resistant flat-lying coarse beds remain in place. Failure plane inclined at 35°
