# HAZARDOUS CRACKS

## RUNNING THROUGH ARIZONA

**People — and their groundwater usage habits — are the source of a hazard in the western United States, in which small cracks in the ground grow to enormous depths, collapsing the earth.**

**Ray Harris and M. Lee Allison**

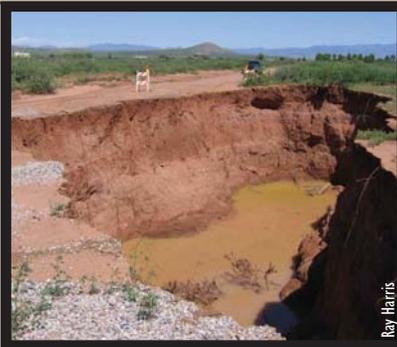
This sinkhole formed last year at the intersection of three giant "desiccation cracks" in southeastern Arizona. Such cracks are the result of dried out clay sediments.

Desiccation cracks typically form at depth and work their way to the surface. Evidence for the initial formation of the desiccation cracks at depth is abundant in the field. It is common to find sinkholes connected by tunnels at depth, with no crack or depression at the surface between them. Such bridging is evidence that the surface has not pulled apart.

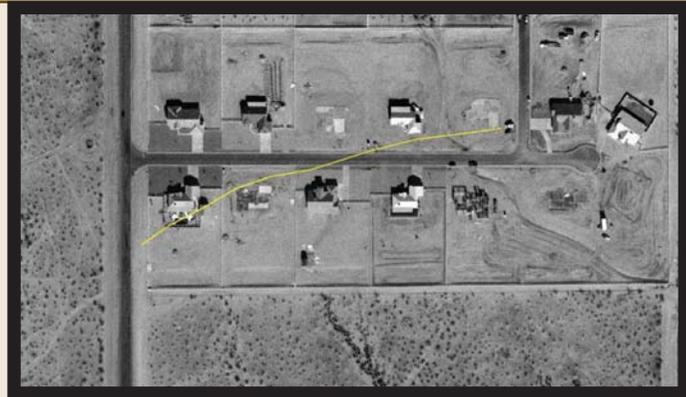
**An aerial photo of an area northeast of Casa Grande, Ariz., shows the rural, undeveloped character of the area in 1997 (left). The dark patch of vegetation in the center is the result of increased water flow into and along an earth fissure, marked with a yellow line. In 2004, a new housing development was built directly over the earth fissure (right). Land owners were not required to disclose the presence of fissures to buyers until a law went into effect this summer.**
