# **Earth Fissure Mapping Program**

## **2006 Progress Report**

**Open-file Report 07- 01  
June, 2007**

**M. Lee Allison, and Todd C. Shipman  
Arizona Geological Survey**

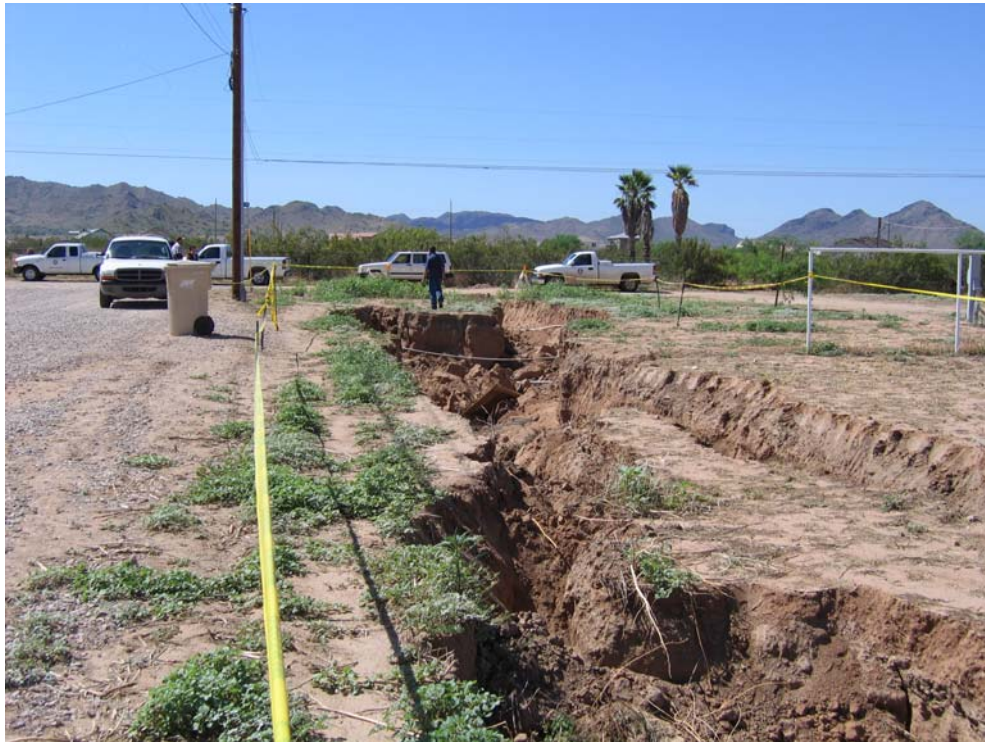
Earth fissure that re-opened overnight in the Chandler Heights area, Maricopa County, following heavy rains. August 25, 2005. Photograph by Ray Harris.
