Earth Fissure Map of the Picacho Study Area: Pinal County, Arizona

February 2009
Arizona Geological Survey

Digital Map Series - Earth Fissure Map 3 (DM-EF-3)

Sheet 1 of 3

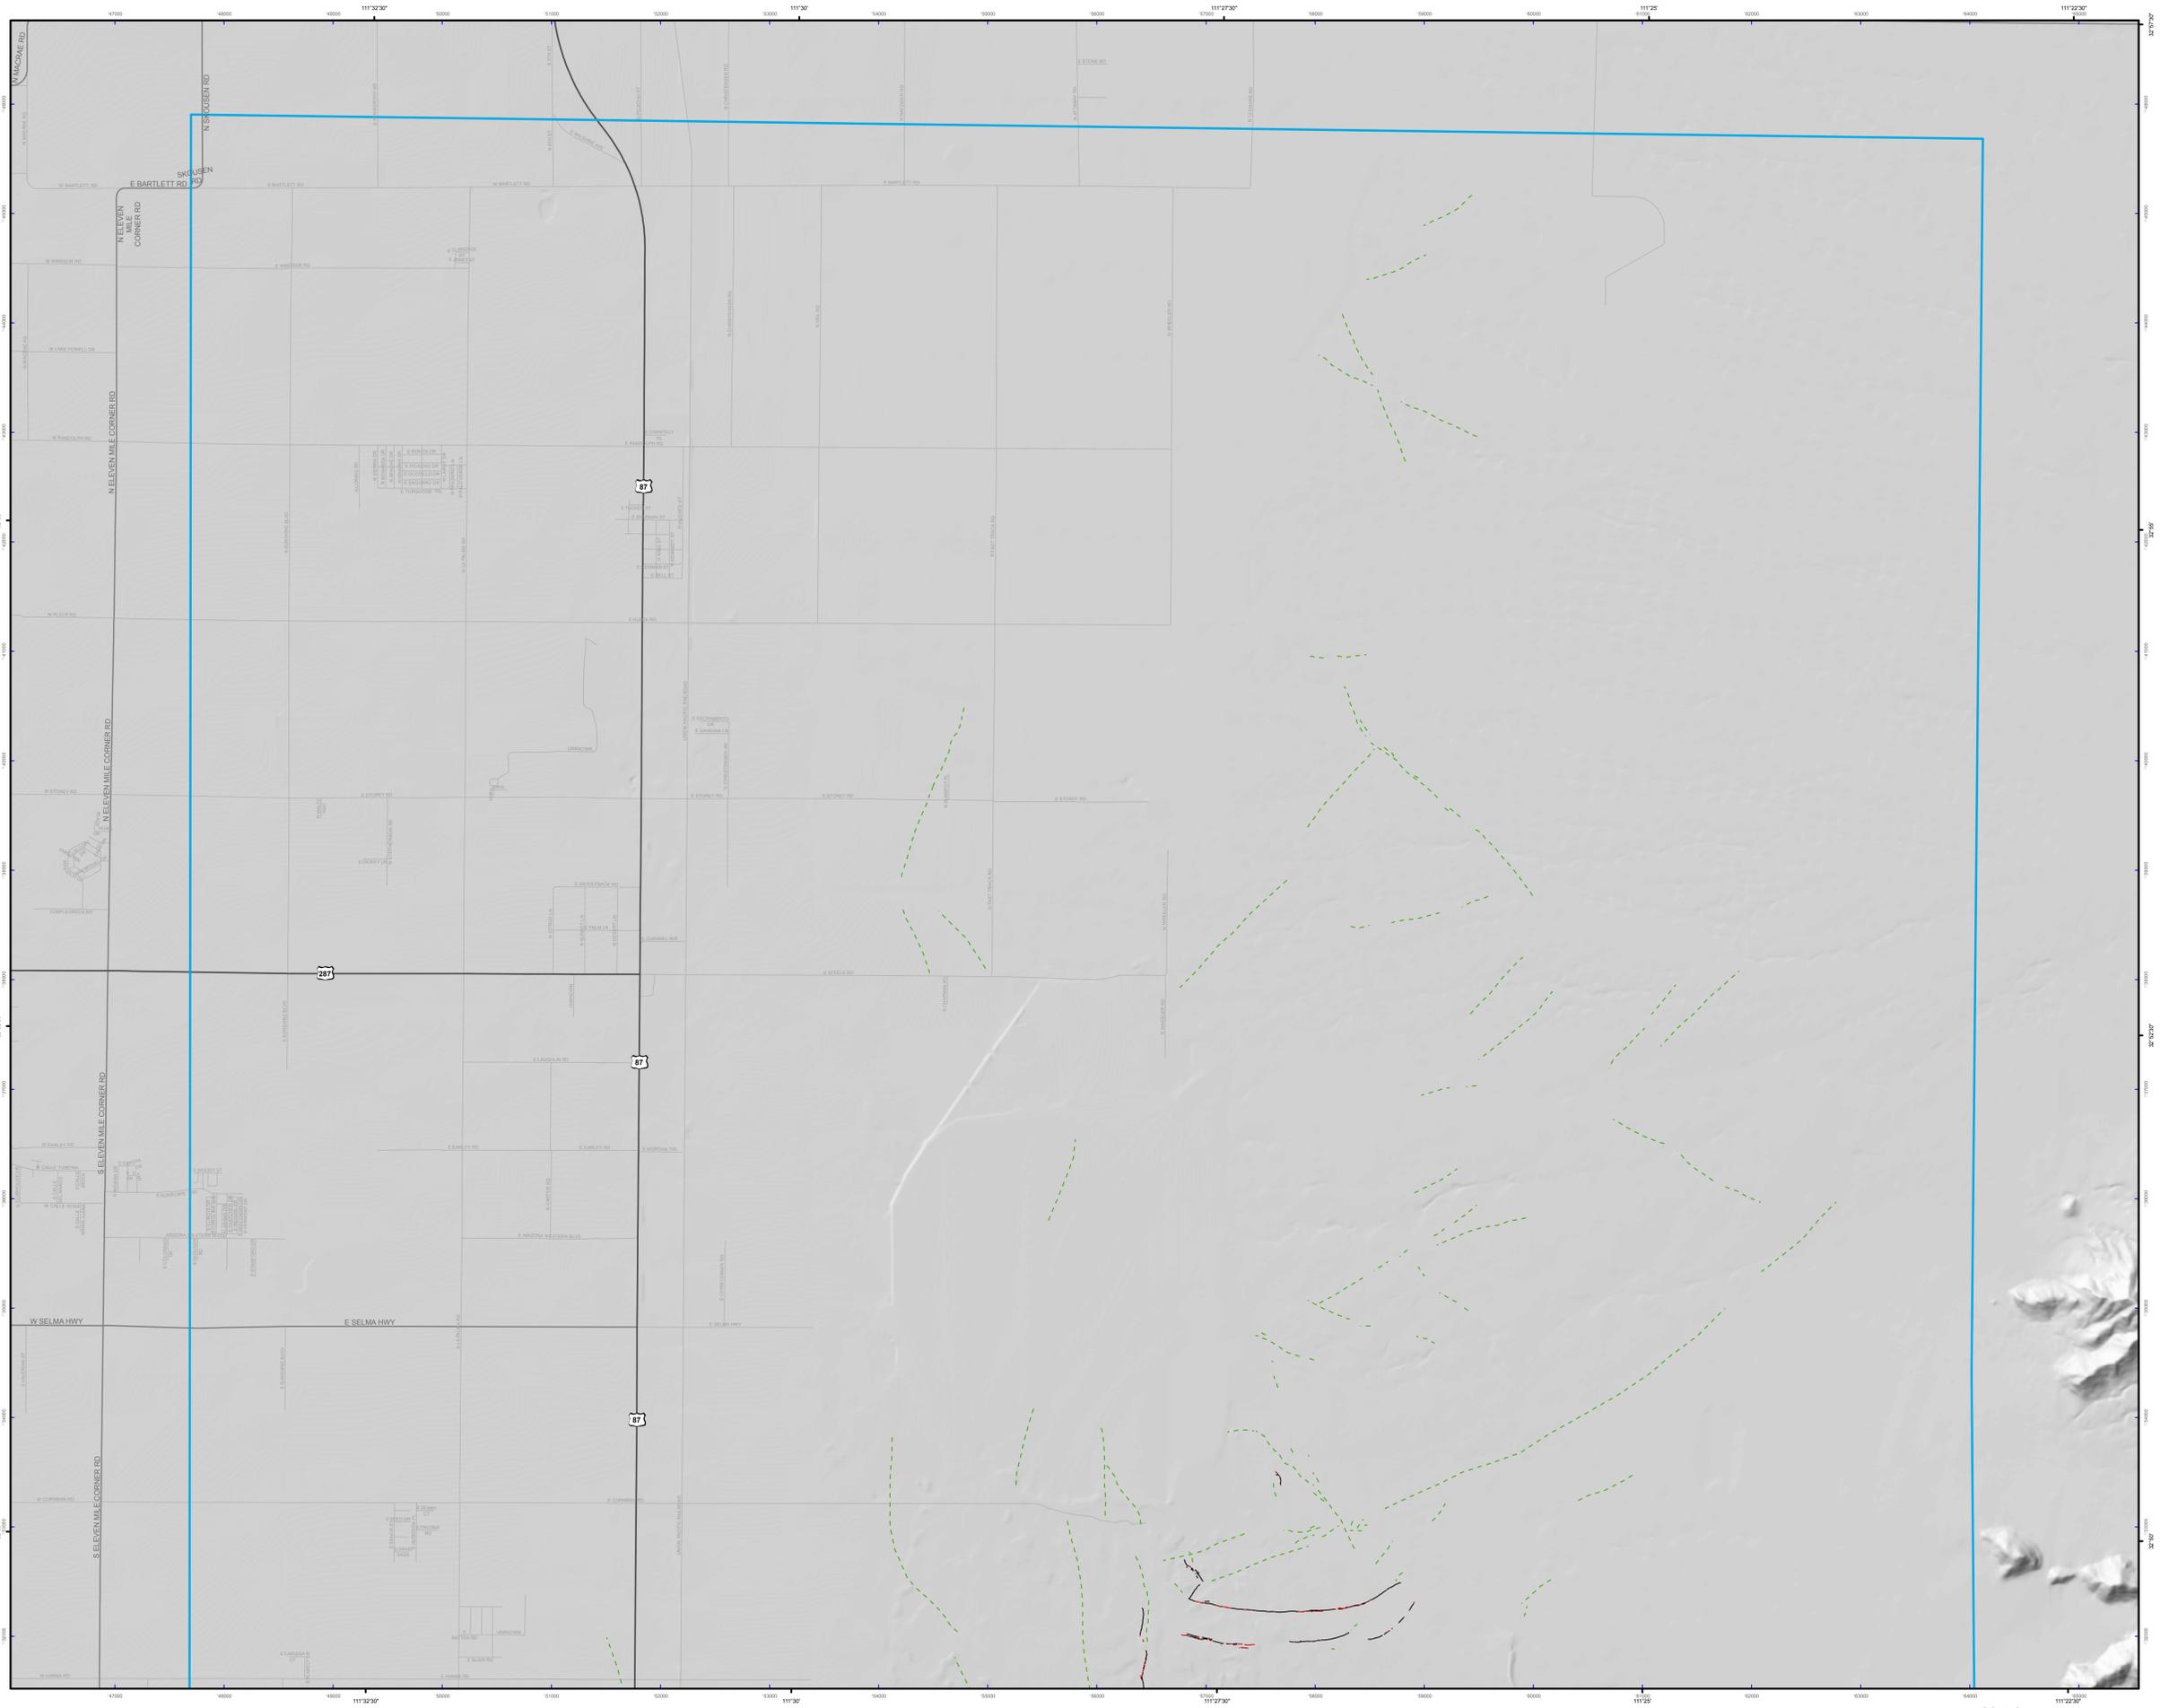
- Solid black lines represent the location of continuous earth fissures manifested as open cracks or gullies.
- Solid red lines represent the location of discontinuous earth fissures manifested as elongated to circular depressions or as abbreviated or irregular linear depressions. These discontinuous surface features frequently represent an incipient surface expression of an earth fissure.
- - - Dashed green lines represent the approximate locations of unconfirmed earth fissures, defined as fissures which could not be confirmed by surface investigations by AZGS geologists, but which have been previously reported by Professional Geologists in published documents or maps.
- The outline of the Study Area is shown in blue.

Historical and modern aerial photos taken within this area were searched for anomalous lineaments. These lineaments were then investigated in the field to determine if there was any evidence of earth fissures.

Shaded relief base map produced from 10m NED Digital Elevation Model

Map projection and blue, 1000-meter grid ticks: Universal Transverse Mercator, zone 12, North American Datum of 1983 NAD83

This is one of a series of earth fissure maps prepared by the Arizona Geological Survey ("AZGS") in accordance with Ariz. Rev. Stat. § 27-152.01(3). AZGS collected location information from previously conducted earth fissure studies, reviewed available remote-sensing aerial and satellite imagery, and conducted surface site investigations throughout the study area. A reasonable effort was made to identify all earth fissures in the study area. Nonetheless, some fissures may remain unmapped as a result of one or more of the following:

- 1) existing fissures may have been masked by construction or agricultural activities;
- 2) incipient fissures may lack clear surface expression;
- 3) the surface expression of fissures changes constantly as new earth fissures develop and old earth fissures fill in.

A blank area on the map does not guarantee earth fissures are not present. However, blank areas within the study area boundary have been investigated, and no surface evidence of fissures was found as of the date of map publication. Determining the presence or absence of a fissure at any specific site may require additional mapping and/or geotechnical analysis.
